Effects of bank vegetation in waterways with special reference to bank erosion, shear strength, root density and channel hydraulics

**Effects of Bank Vegetation in Waterways with Special
Reference to Bank Erosion, Shear Strength, Root Density and
Channel Hydraulics**

**A thesis submitted to the Open University
for the Degree of Doctor of Philosophy
Biology Department
September 1992**

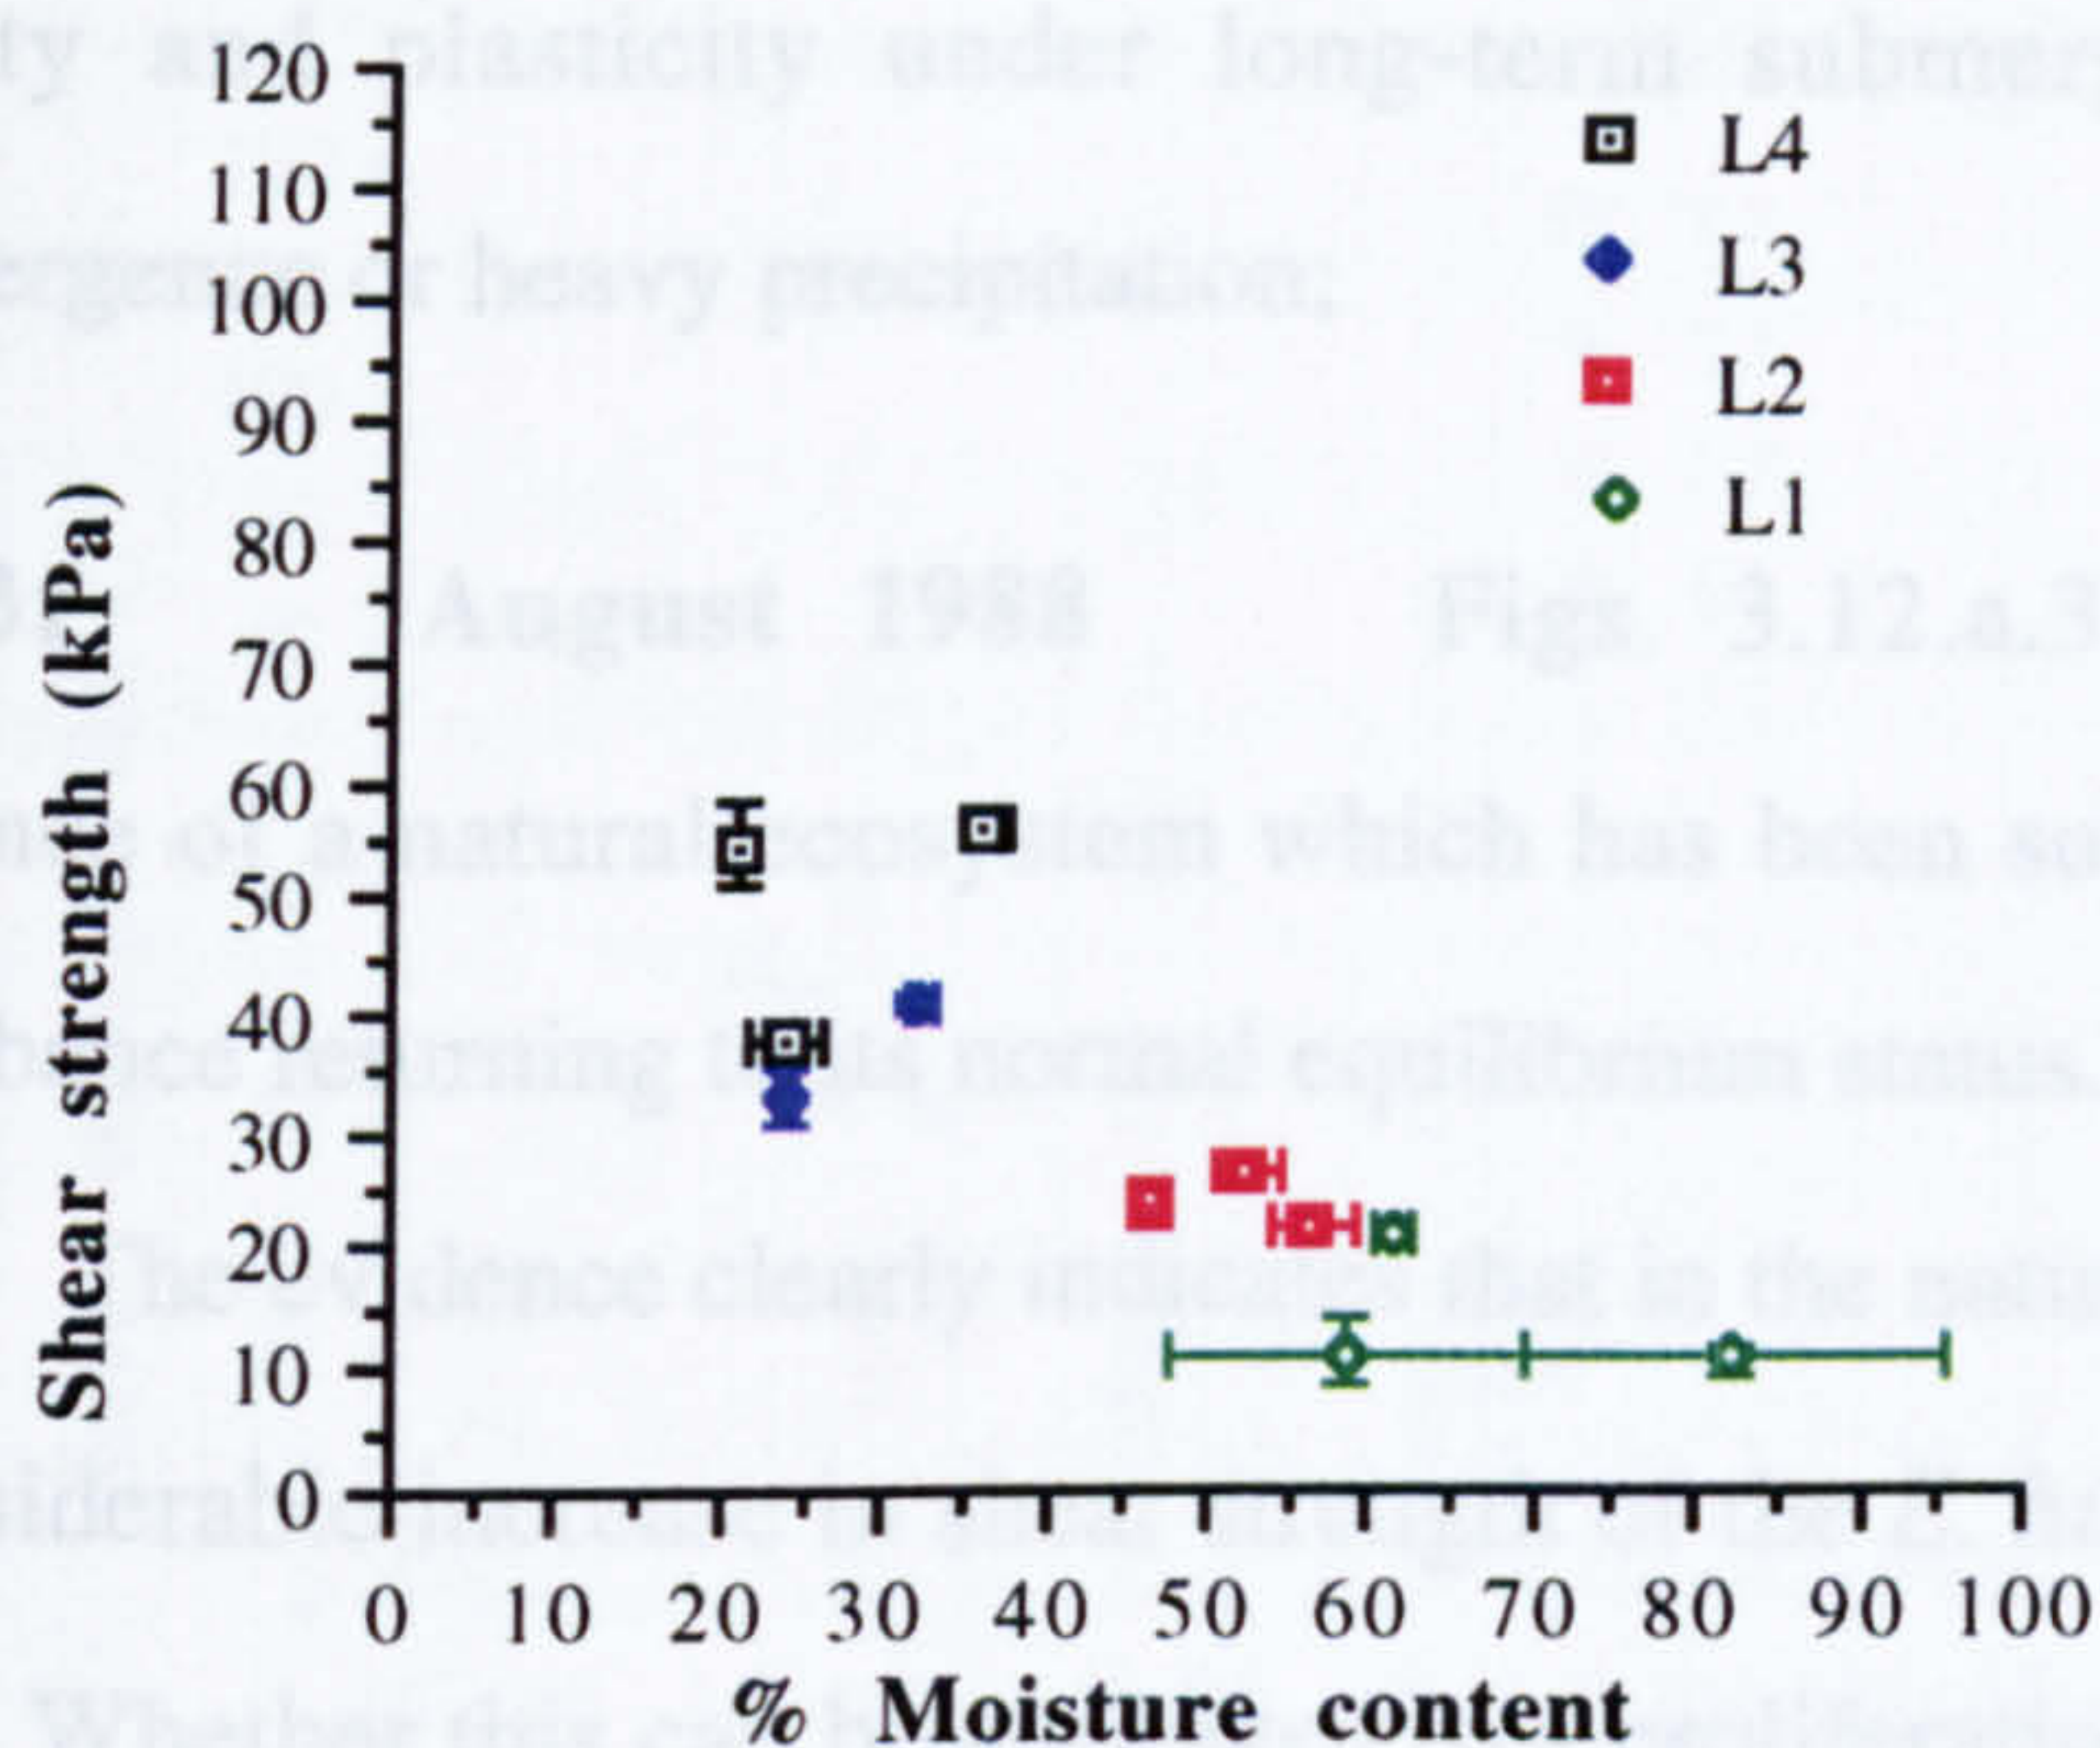
Fig. 3.11a: Shear strength Vs. Moisture content variations (May 1988)
Bare banks

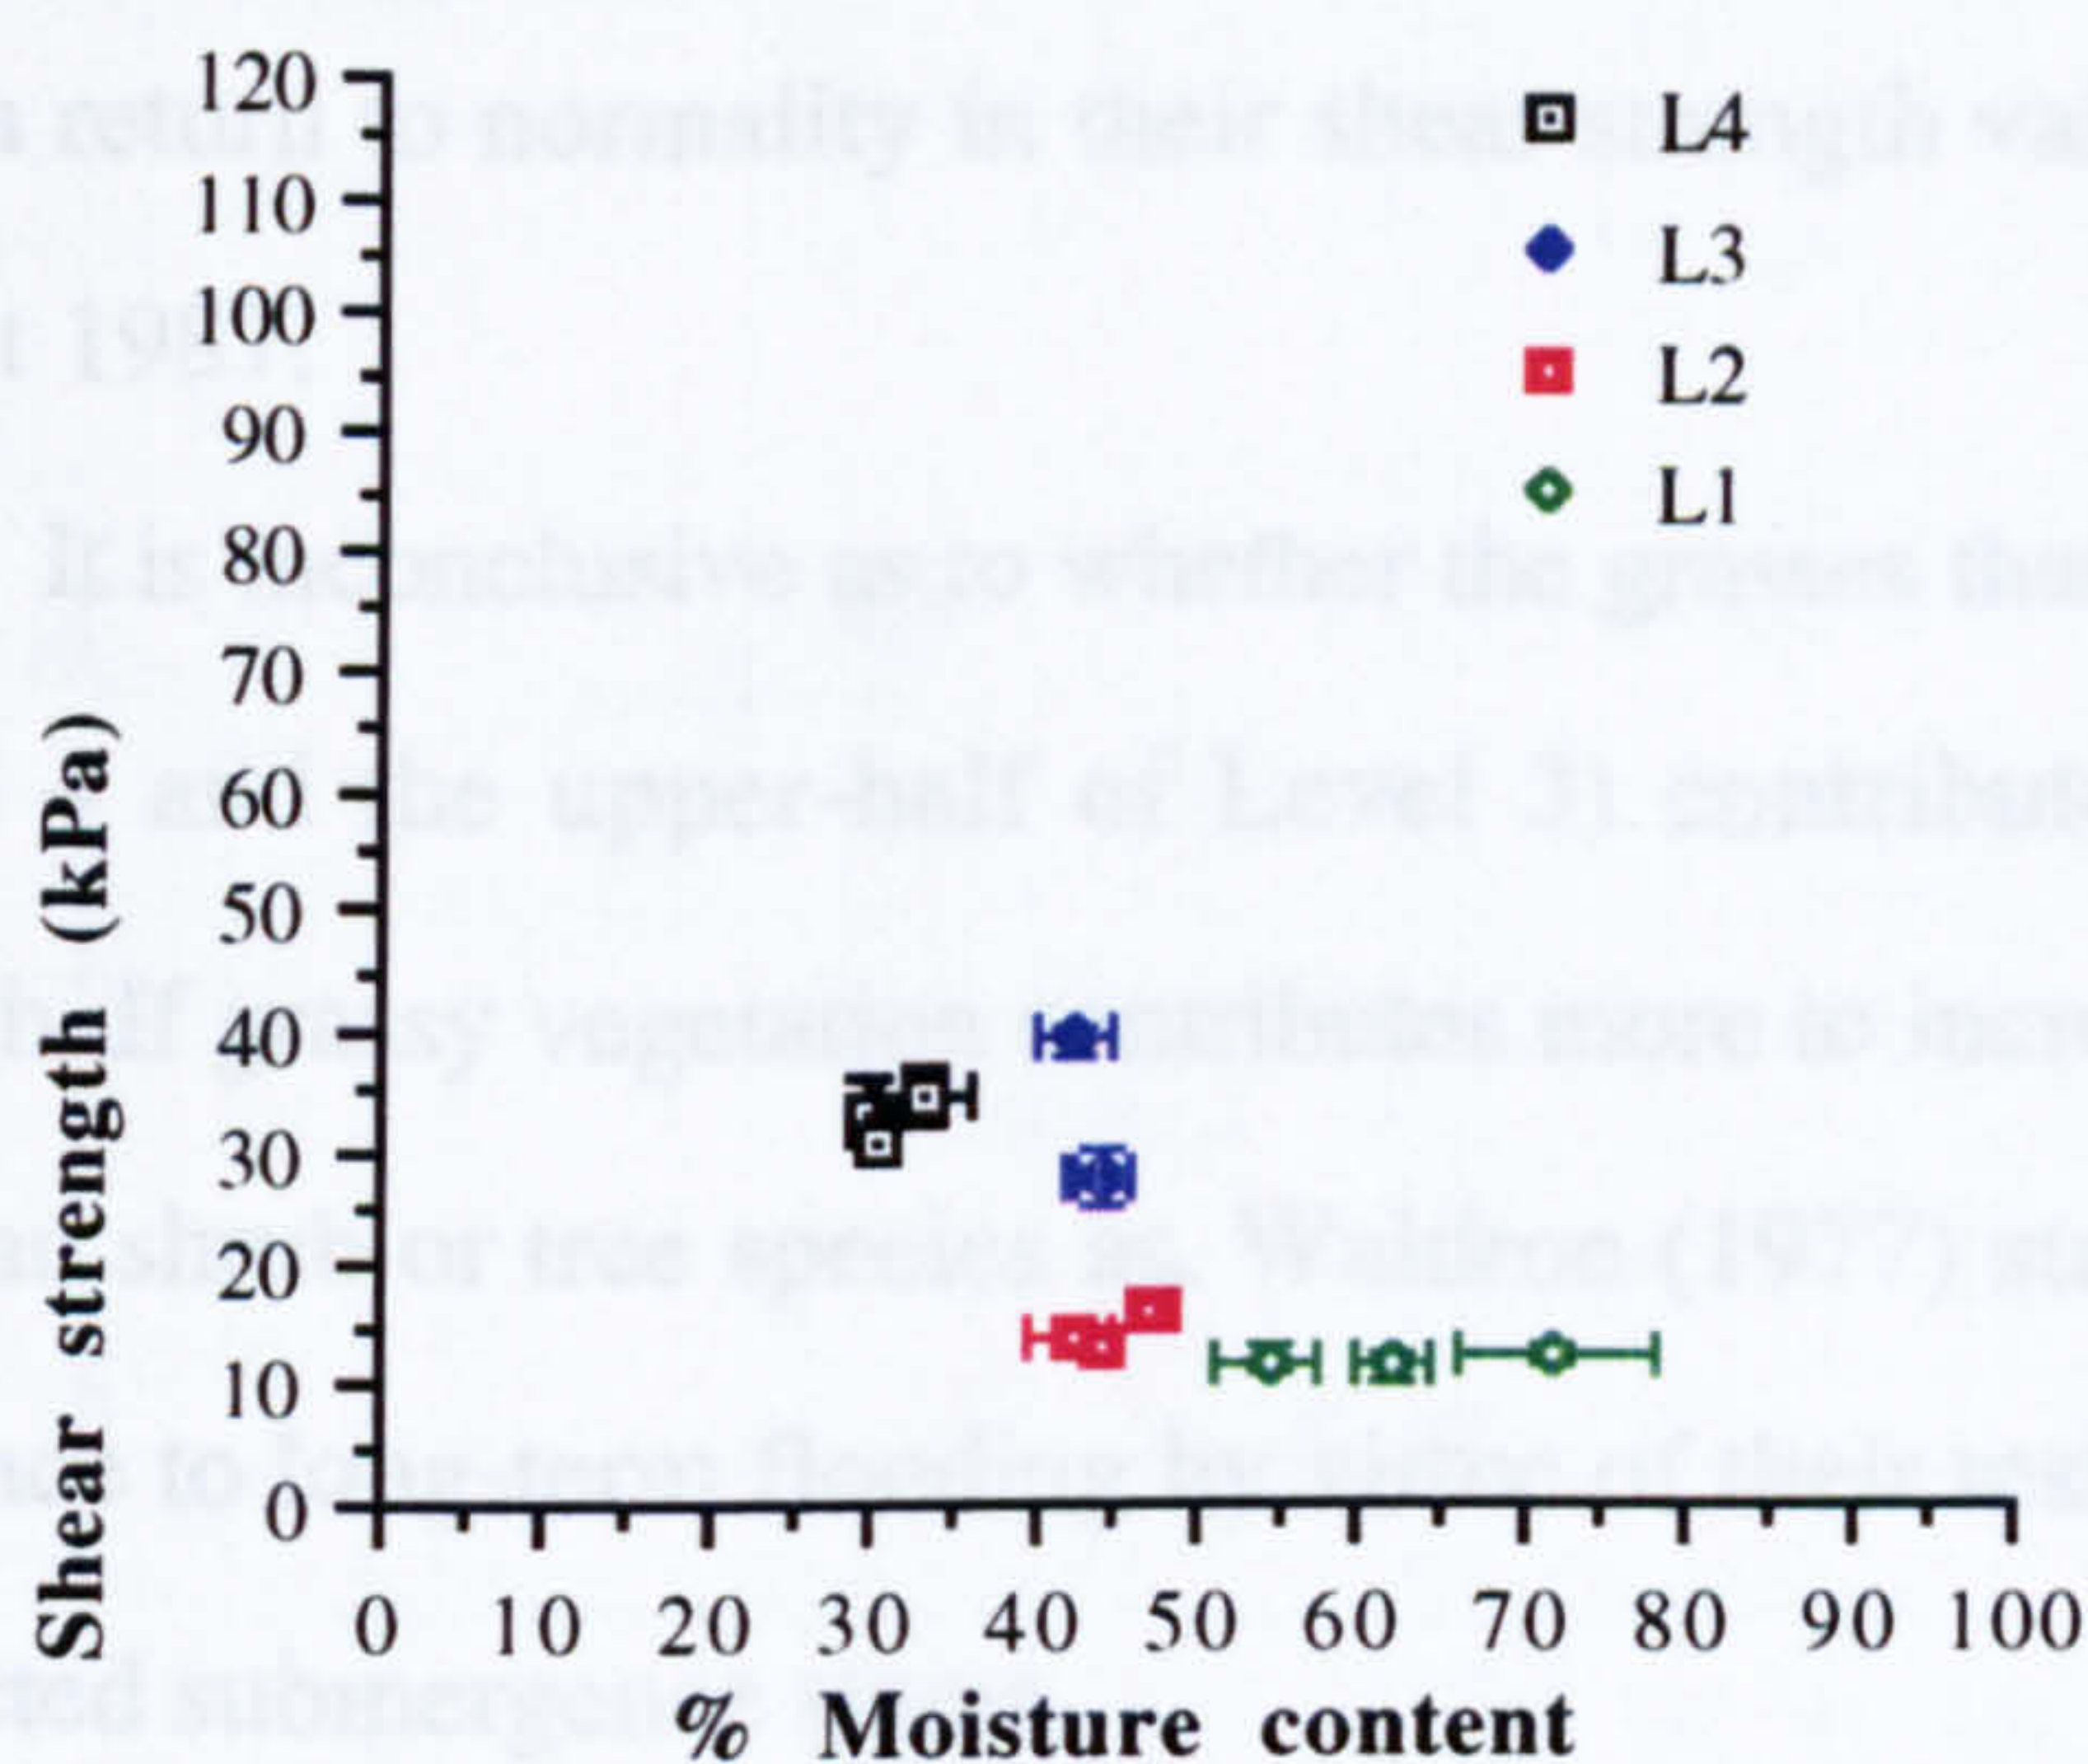
Fig. 3.11b: Shear strength Vs. Moisture content variations (May 1988)
Naturally vegetated banks dominated by *E. hirsutum* at levels 2 to 4

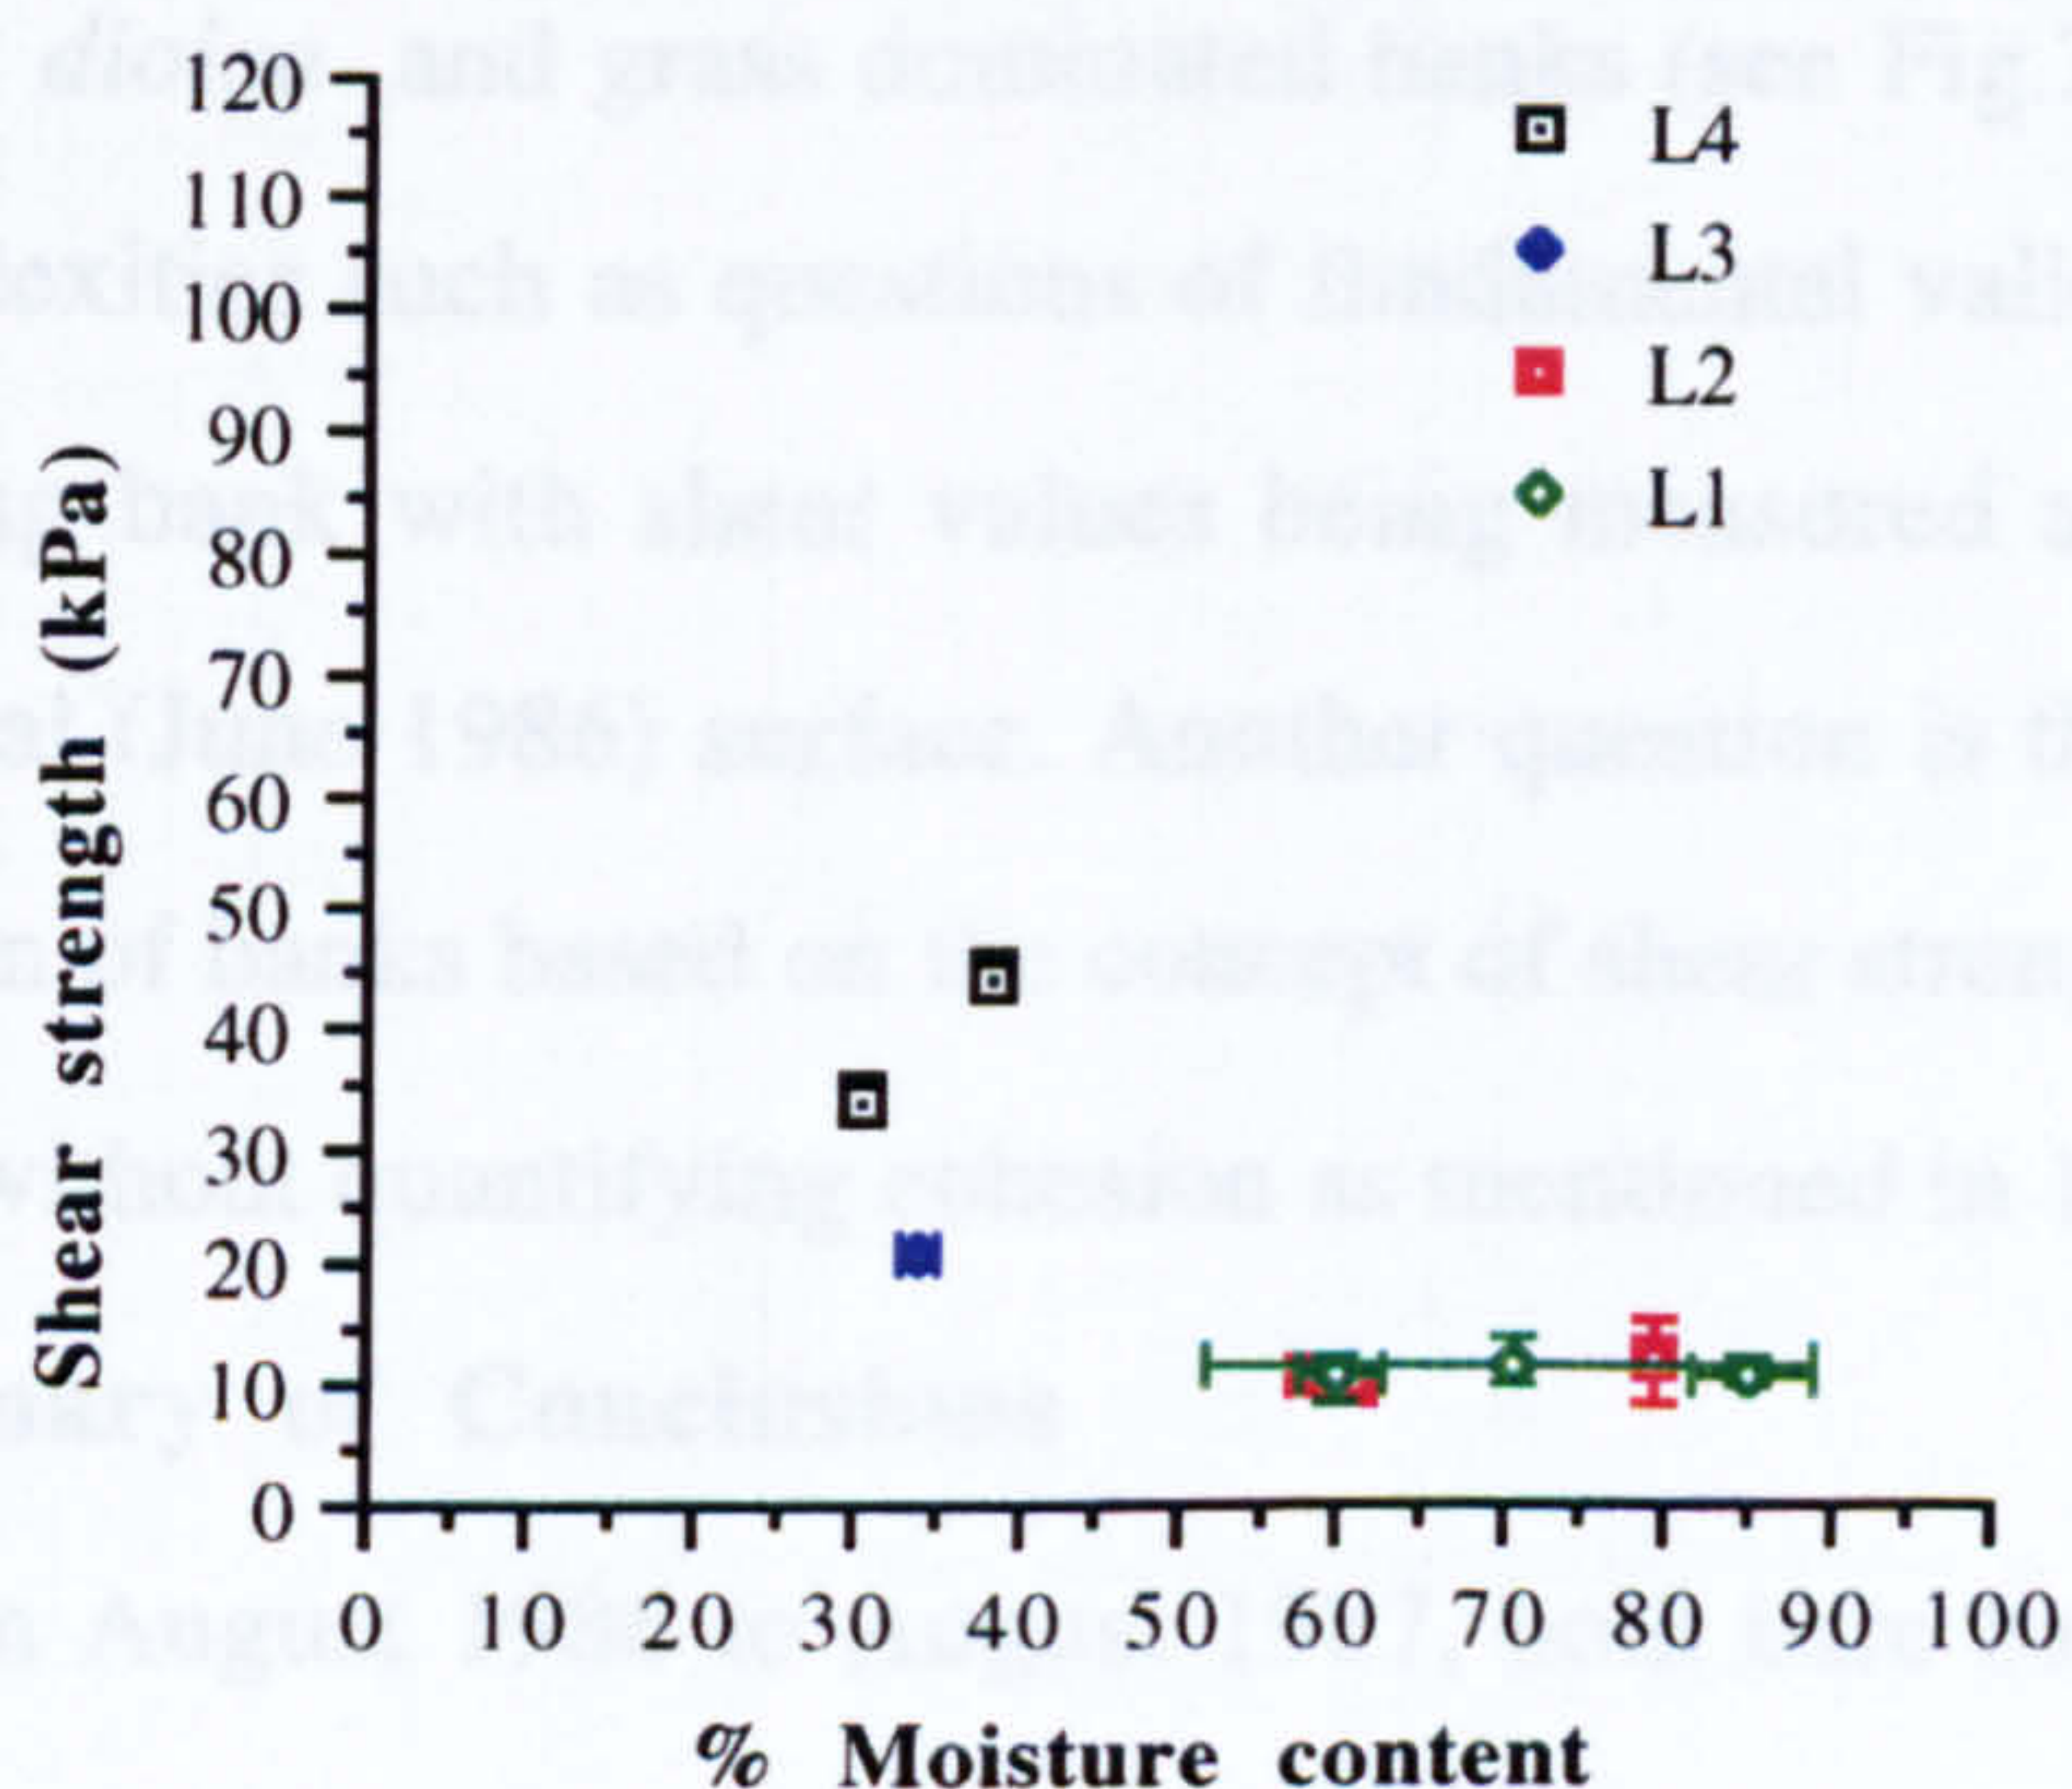
Fig. 3.11c: Shear strength Vs. Moisture content variations (May 1988)
Naturally vegetated banks dominated by *U. dioica* at levels 2 to 4

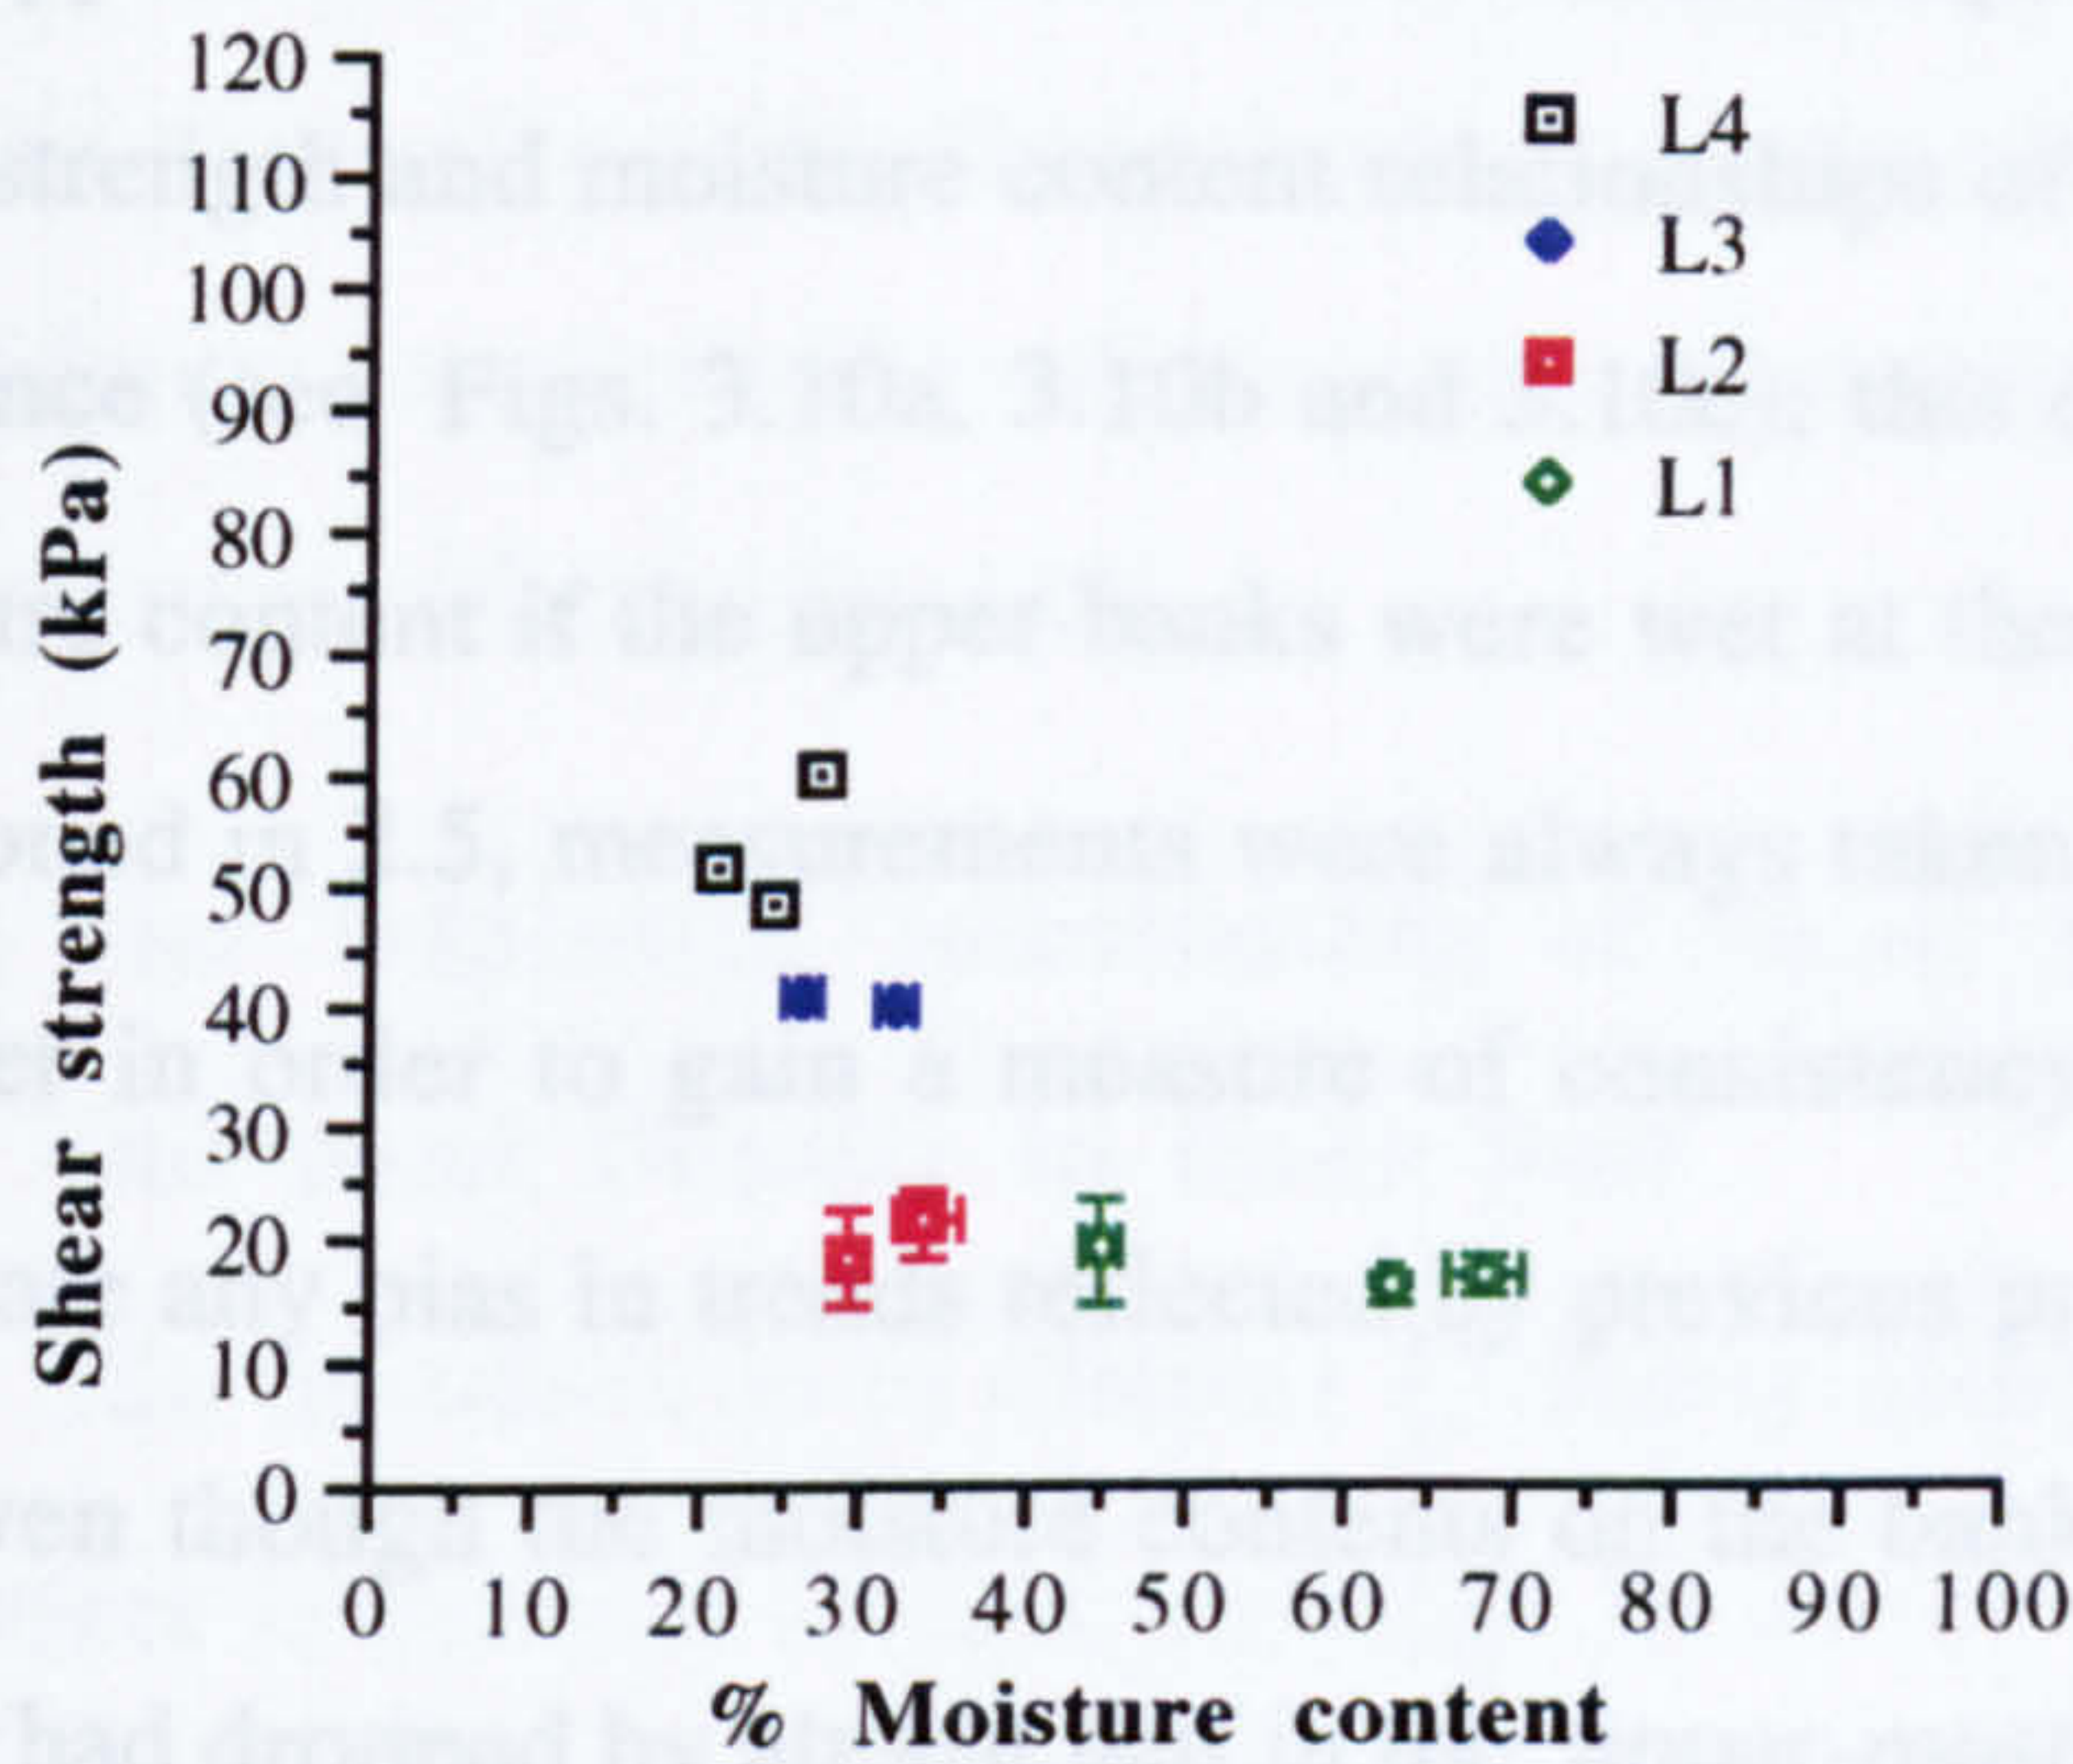
Fig. 3.12a: Shear strength Vs. Moisture content variations (August 1988)
Bare banks

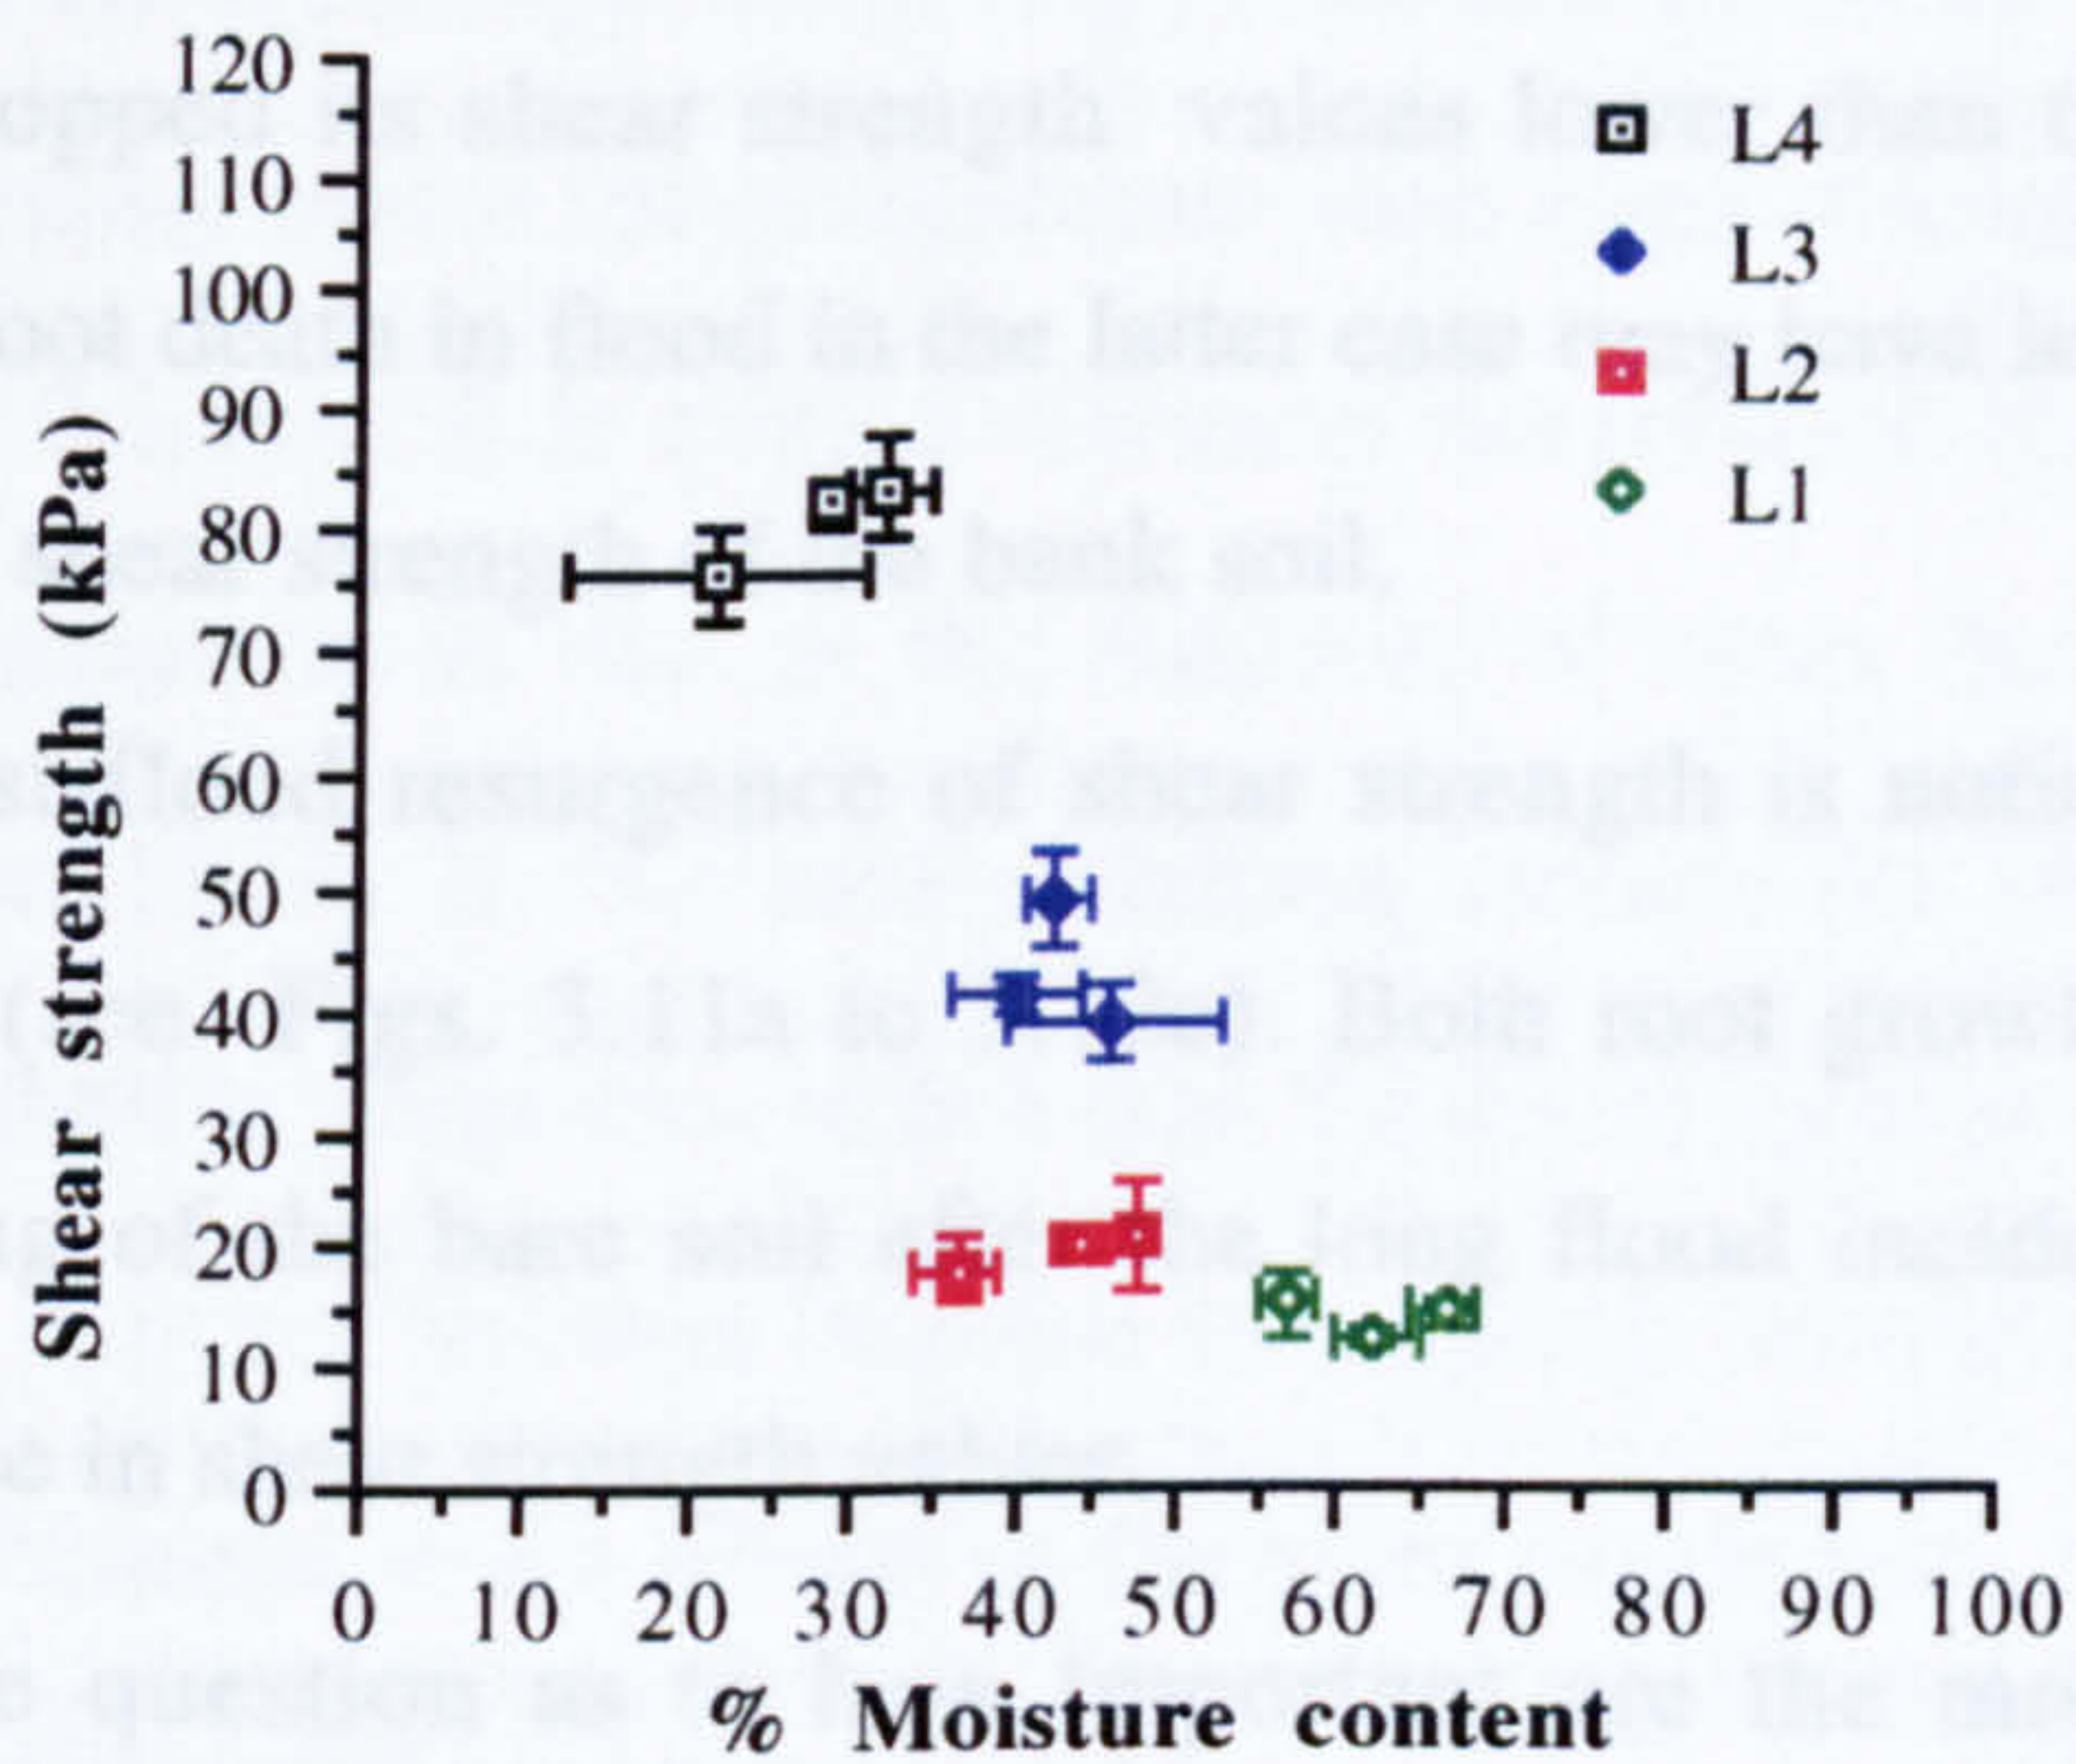
Fig. 3.12b: Shear strength Vs. Moisture content variations (August 1988)
Naturally vegetated banks dominated by U. dioica

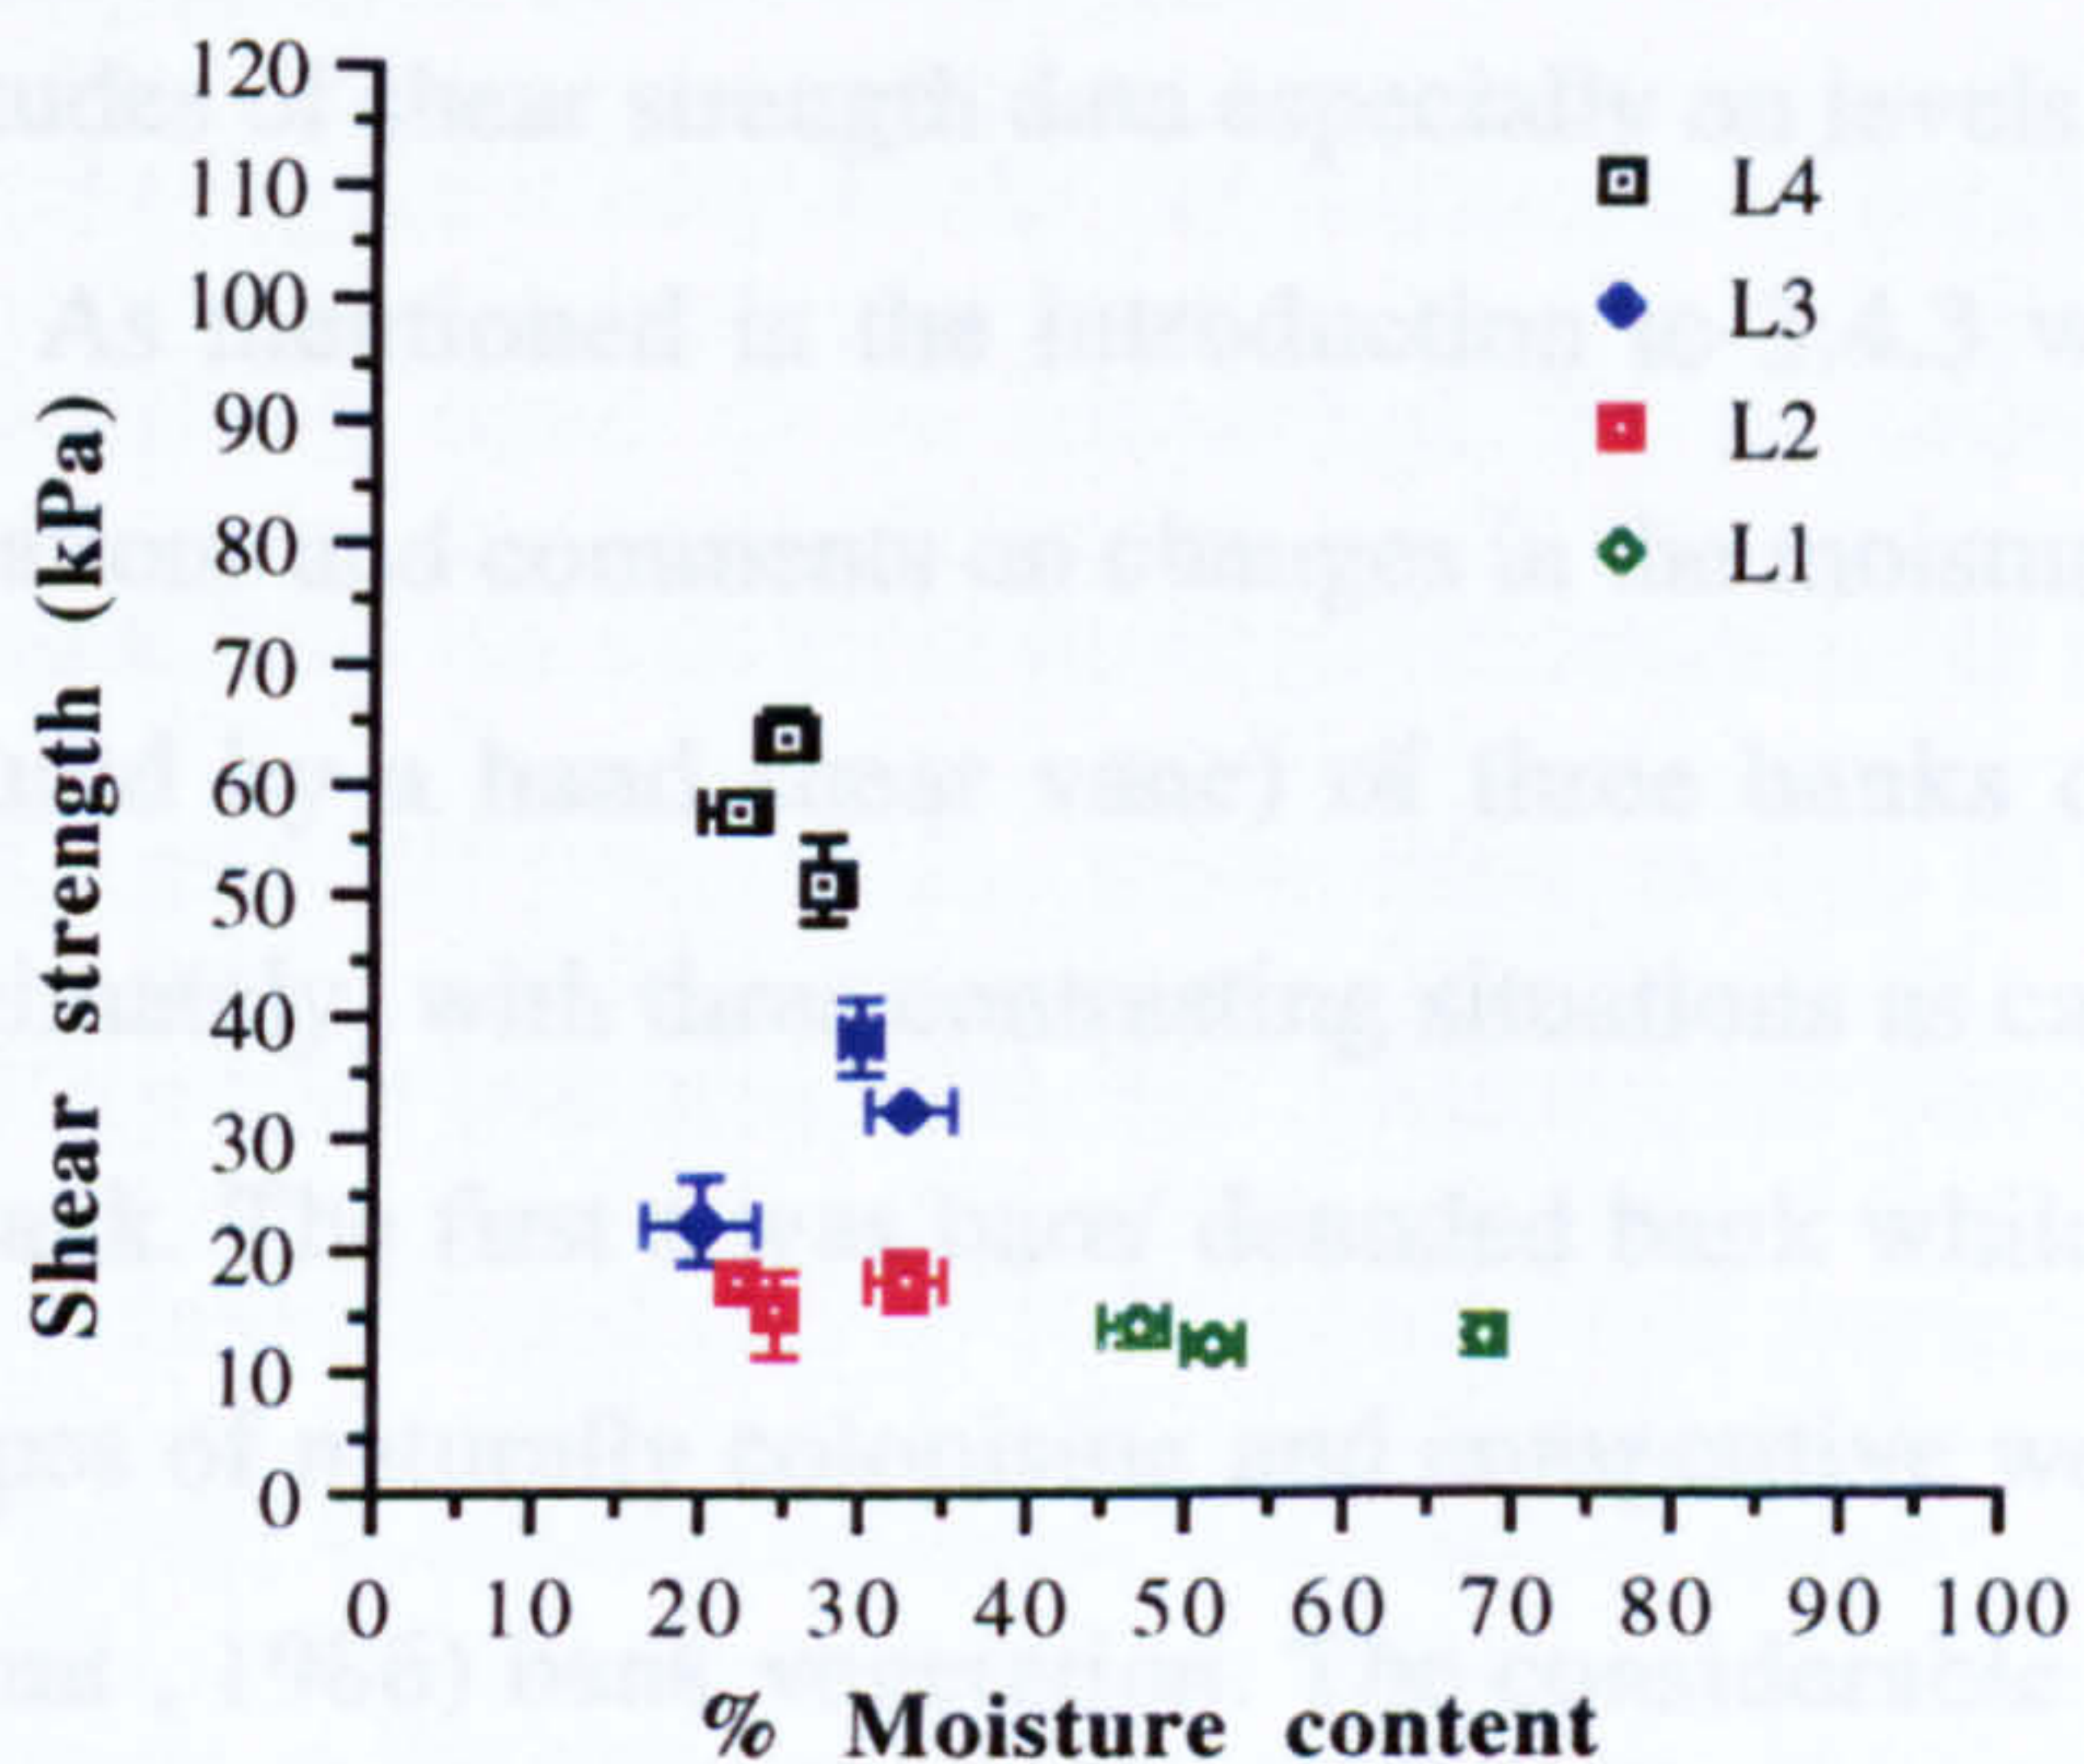
Fig. 3.12c: Shear strength and Moisture content variations (August 1988)
Naturally vegetated banks dominated by U. dioica at levels 2 to 4
